Check Travel Stops – Near-miss

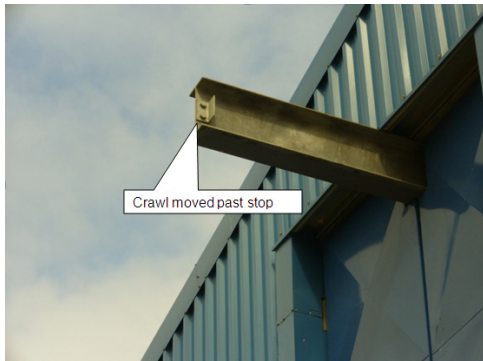
Around 10:40 a.m., the crawl proceeded past the stops installed on the 'I' beam while raising an agitator shaft at a workshop, and the weight fell to the ground. The proper work approach was employed, staff had just received rigging training, and a Job Safety Analysis was done before to beginning.

Although it did not contribute to the event, it was discovered during the I-cam that the chain block utilized was excessively short, necessitating the use of a forklift to raise the weight. There were no casualties and very little property damage as a result of this incident. Because the possible conclusion was serious, a thorough examination was conducted.

- A design flaw: the end stops were too short, causing the crawl to roll off the end of the beam and plummet.
- Deficiencies in the system for inspecting and testing lifting equipment safety devices.
- A third party performed a load test on the beam. The checklist they employ just asks them to verify the bolts on the stops and whether or not the stops are installed. The effectiveness of the safety device (stops) is not physically checked.

- All crawl beams were evaluated to identify potential comparable issues.
- Redesign stops on damaged beams, including fitting and testing substitute stops as needed.
- The supplier was asked to include a sign-off operational check of the overhead channel I-beam safety device on their inspection checklist (end stops).
- This exercise was rolled out across Operations and the Group. As a consequence, comparable flaws were detected and corrected before they could cause an accident.
