Check Travel Stops – Near-miss

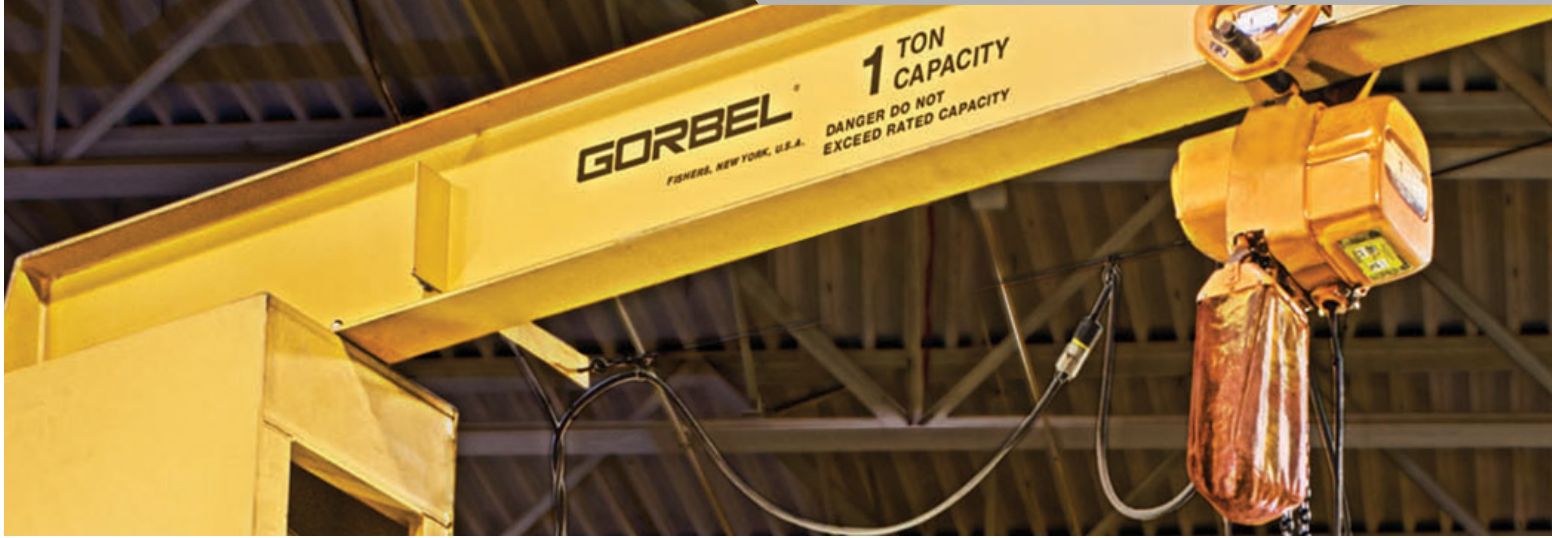
Around 10:40 a.m., the crawl proceeded past the stops installed on the 'I' beam while raising an agitator shaft at a workshop, and the weight fell to the ground. The proper work approach was employed, staff had just received rigging training, and a Job Safety Analysis was done before to beginning.

- A design flaw: the end stops were too short, causing the crawl to roll off the end of the beam and plummet.
- Deficiencies in the system for inspecting and testing lifting equipment safety devices.
- A third party performed a load test on the beam. The checklist they employ just asks them to verify the bolts on the stops and whether or not the stops are installed. The effectiveness of the safety device (stops) is not physically checked.

- All crawl beams were evaluated to identify potential comparable issues.
- Redesign stops on damaged beams, including fitting and testing substitute stops as needed.
- The supplier was asked to include a sign-off operational check of the overhead channel I-beam safety device on their inspection checklist (end stops).
- This exercise was rolled out across Operations and the Group. As a consequence, comparable flaws were detected and corrected before they could cause an accident.
